Conserving an Icon

St. Patrick's Cathedral, New York, NY

Murphy Burnham & Buttrick; New York, NY; Jeffrey Murphy, AIA, LEED AP, partner-in-charge; Rolando Kraeher, AIA, project architect; Jean Phifer, FAIA, stained-glass specialist; Sarah Rosenblatt, preservationist

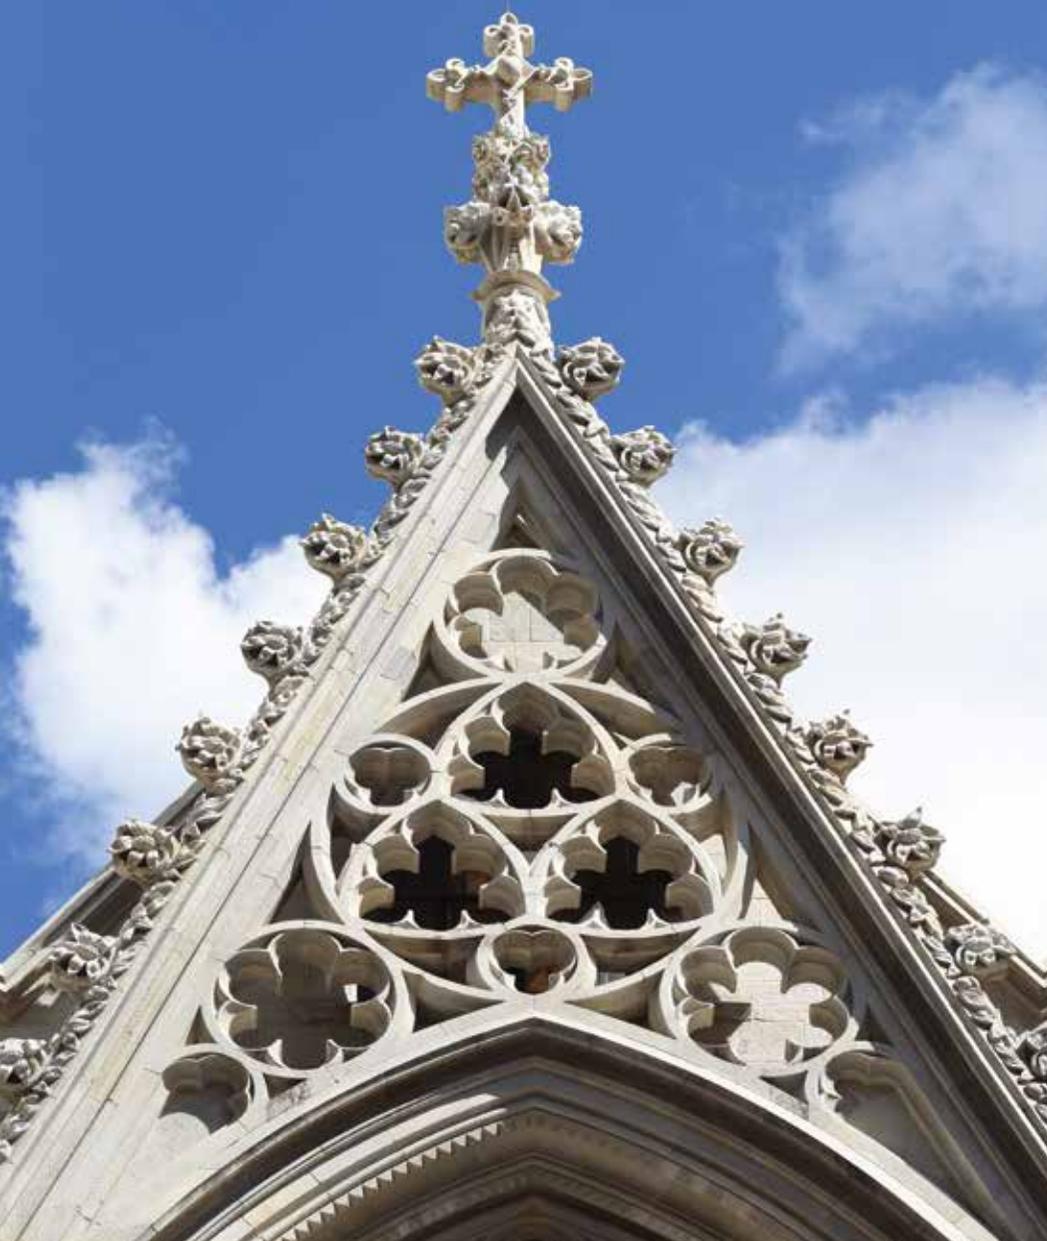
ABOVE: This detail of one of the exterior spires illustrates the artistry of the detail on the marble exterior of the cathedral. The spires reach 329 ft. 6 in. into the sky and were completed in 1888. Photo: Murphy Burnham & Buttrick

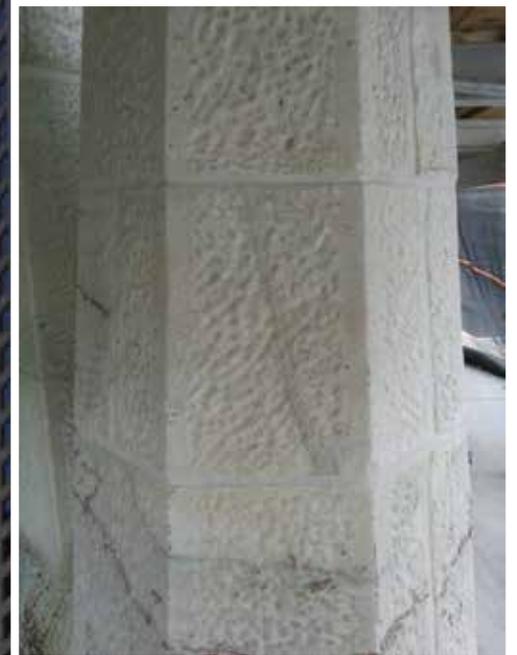
ABOVE: Of the 30,000 individual repairs made to the cathedral, 18,000 were located on the exterior. Here is one example of a crack repair. Photo: Murphy Burnham & Buttrick

The building required 30,000 separate repairs, and 18,000 of those were on the marble exterior which had turned a dingy gray over the years. Most of it is Tuckahoe marble from Westchester, NY, along with Cockeysville marble from Maryland and Lee marble from the Berkshires in Massachusetts. “Because the Tuckahoe marble quarry has been closed for over 75 years, previous campaigns used a significant amount of gray Georgia marble that does not really match the creamy Tuckahoe or Lee. This inspired us to find real Tuckahoe for our repairs, which we did,” Pepi points out.

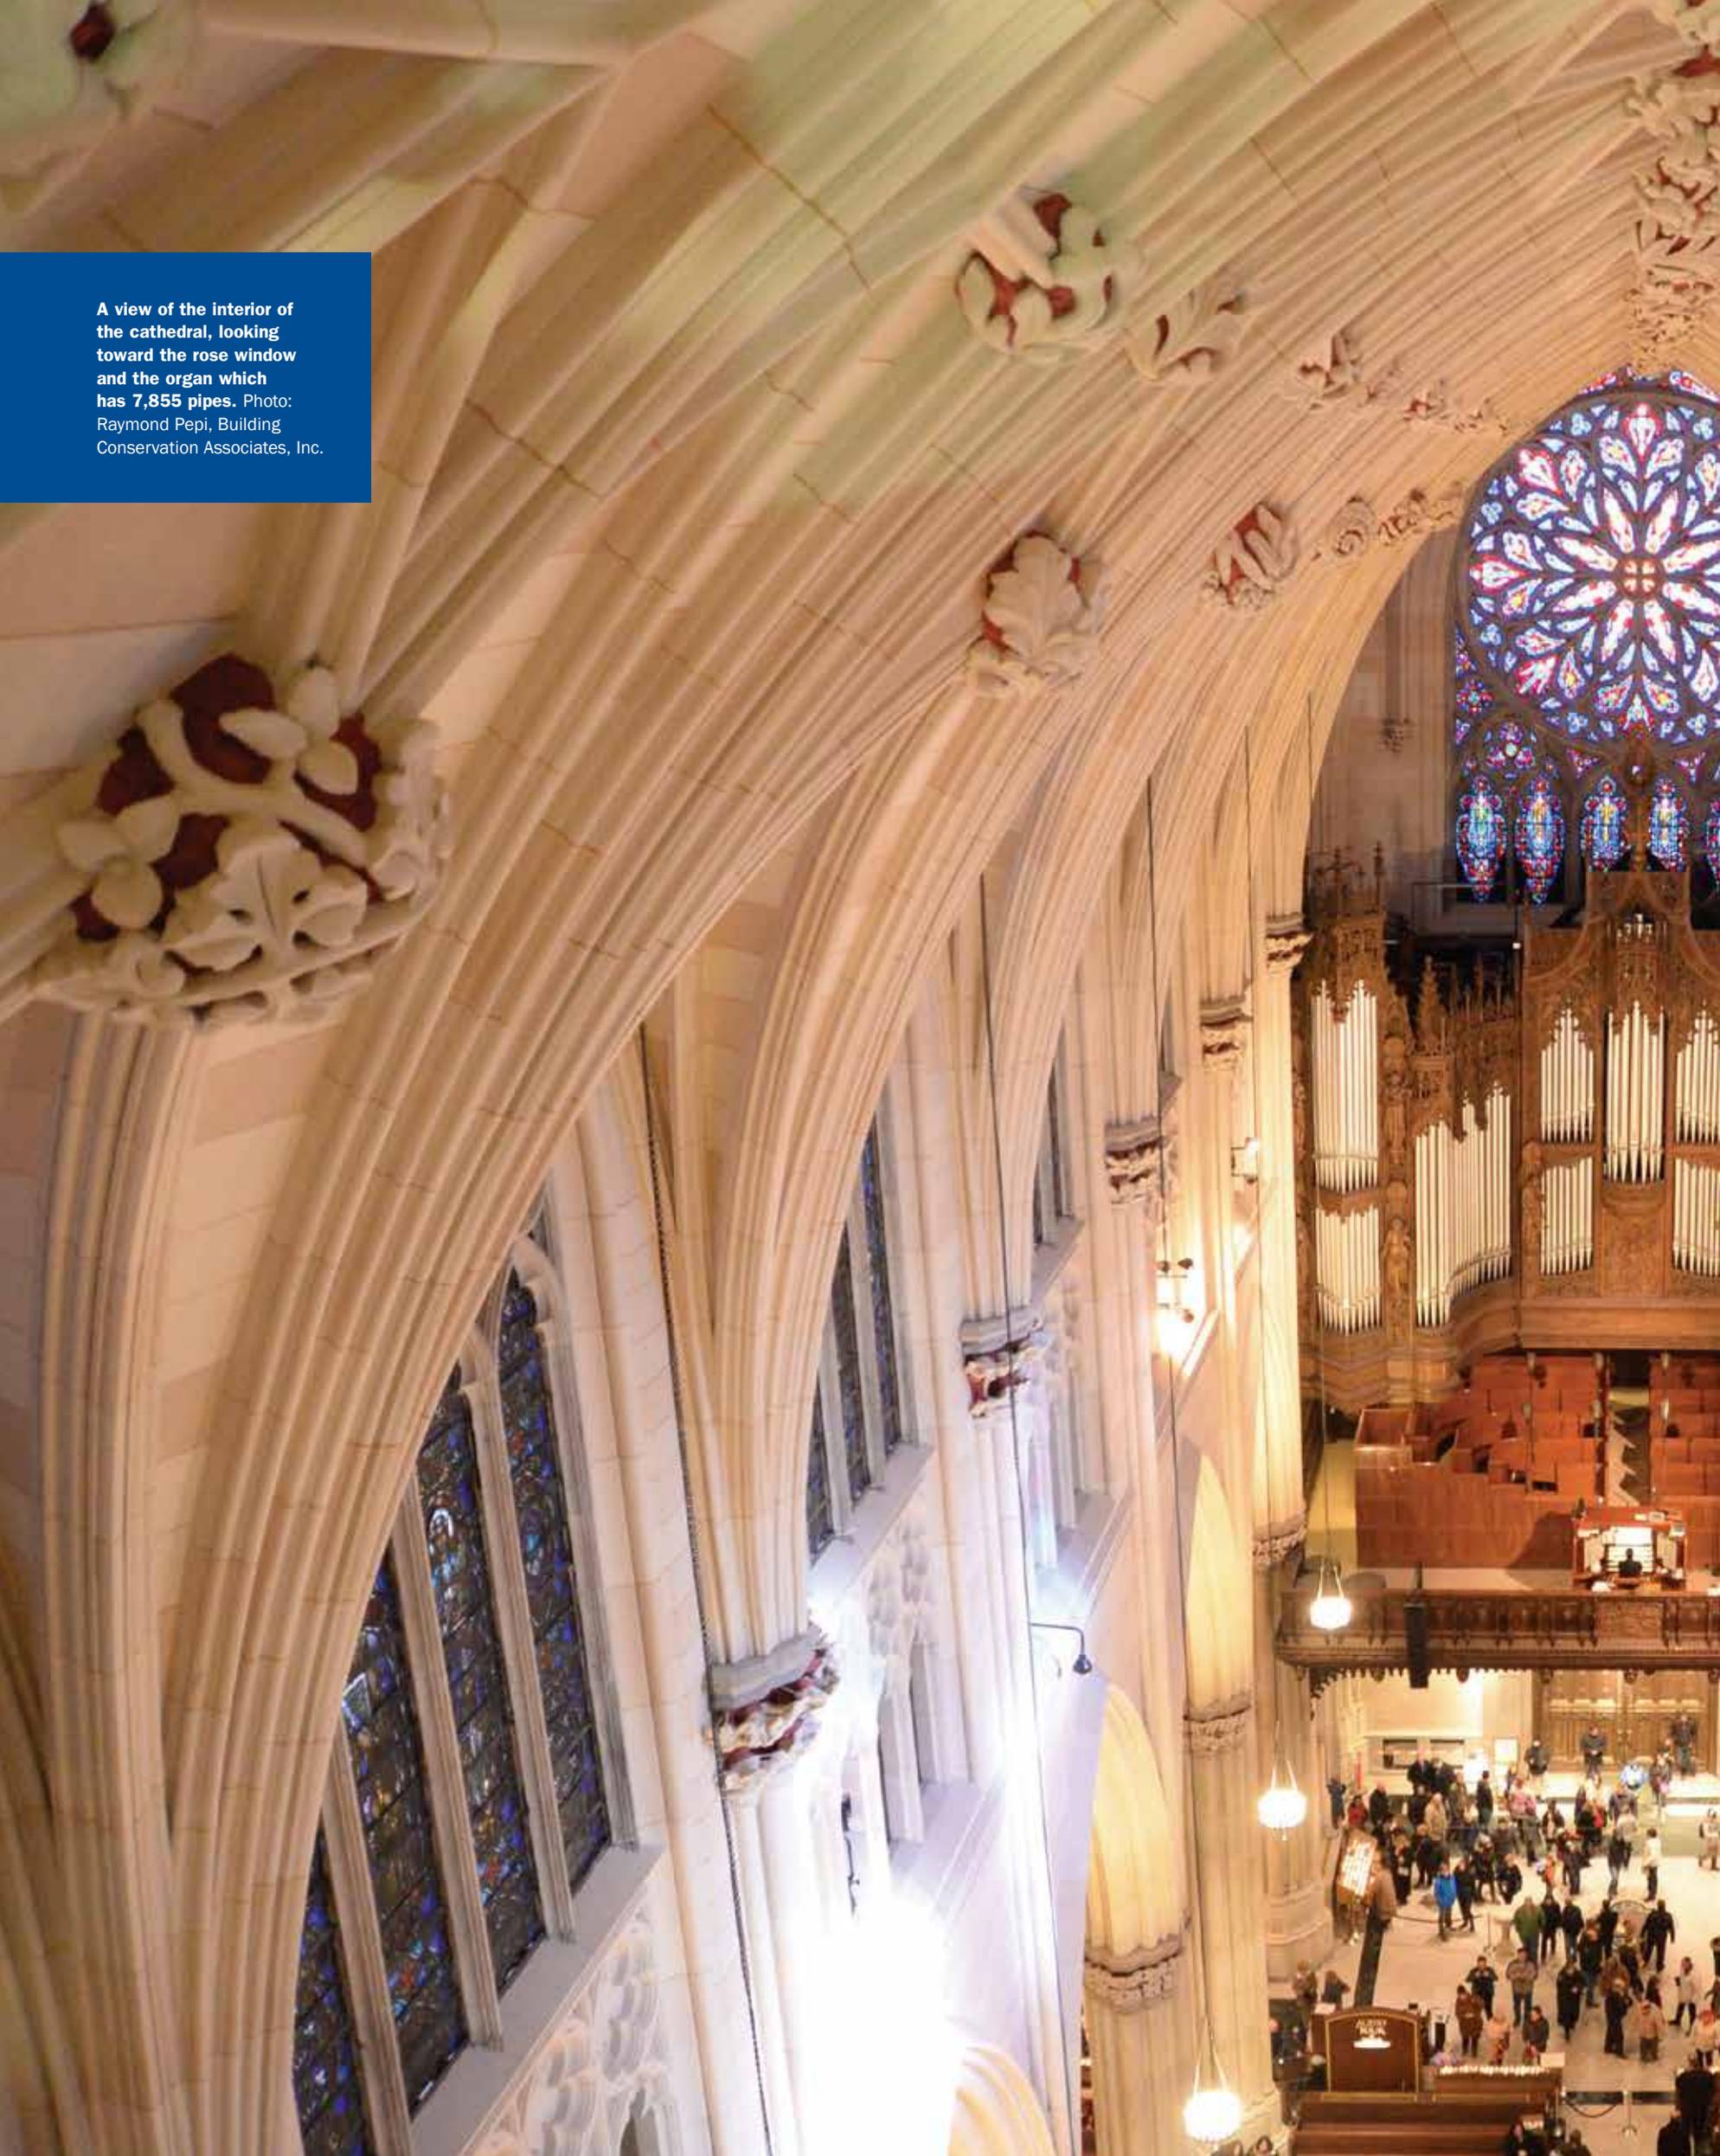
A view of the interior of the cathedral, looking toward the rose window and the organ which has 7,855 pipes. Photo: Raymond Pepi, Building Conservation Associates, Inc.

The cathedral’s two organs were also repaired and restored. The larger one has 7,855 pipes ranging in length from 32 ft. ½-in. and a second one has 1,480 pipes. Both were restored by Peragallo Pipe Organ Company.

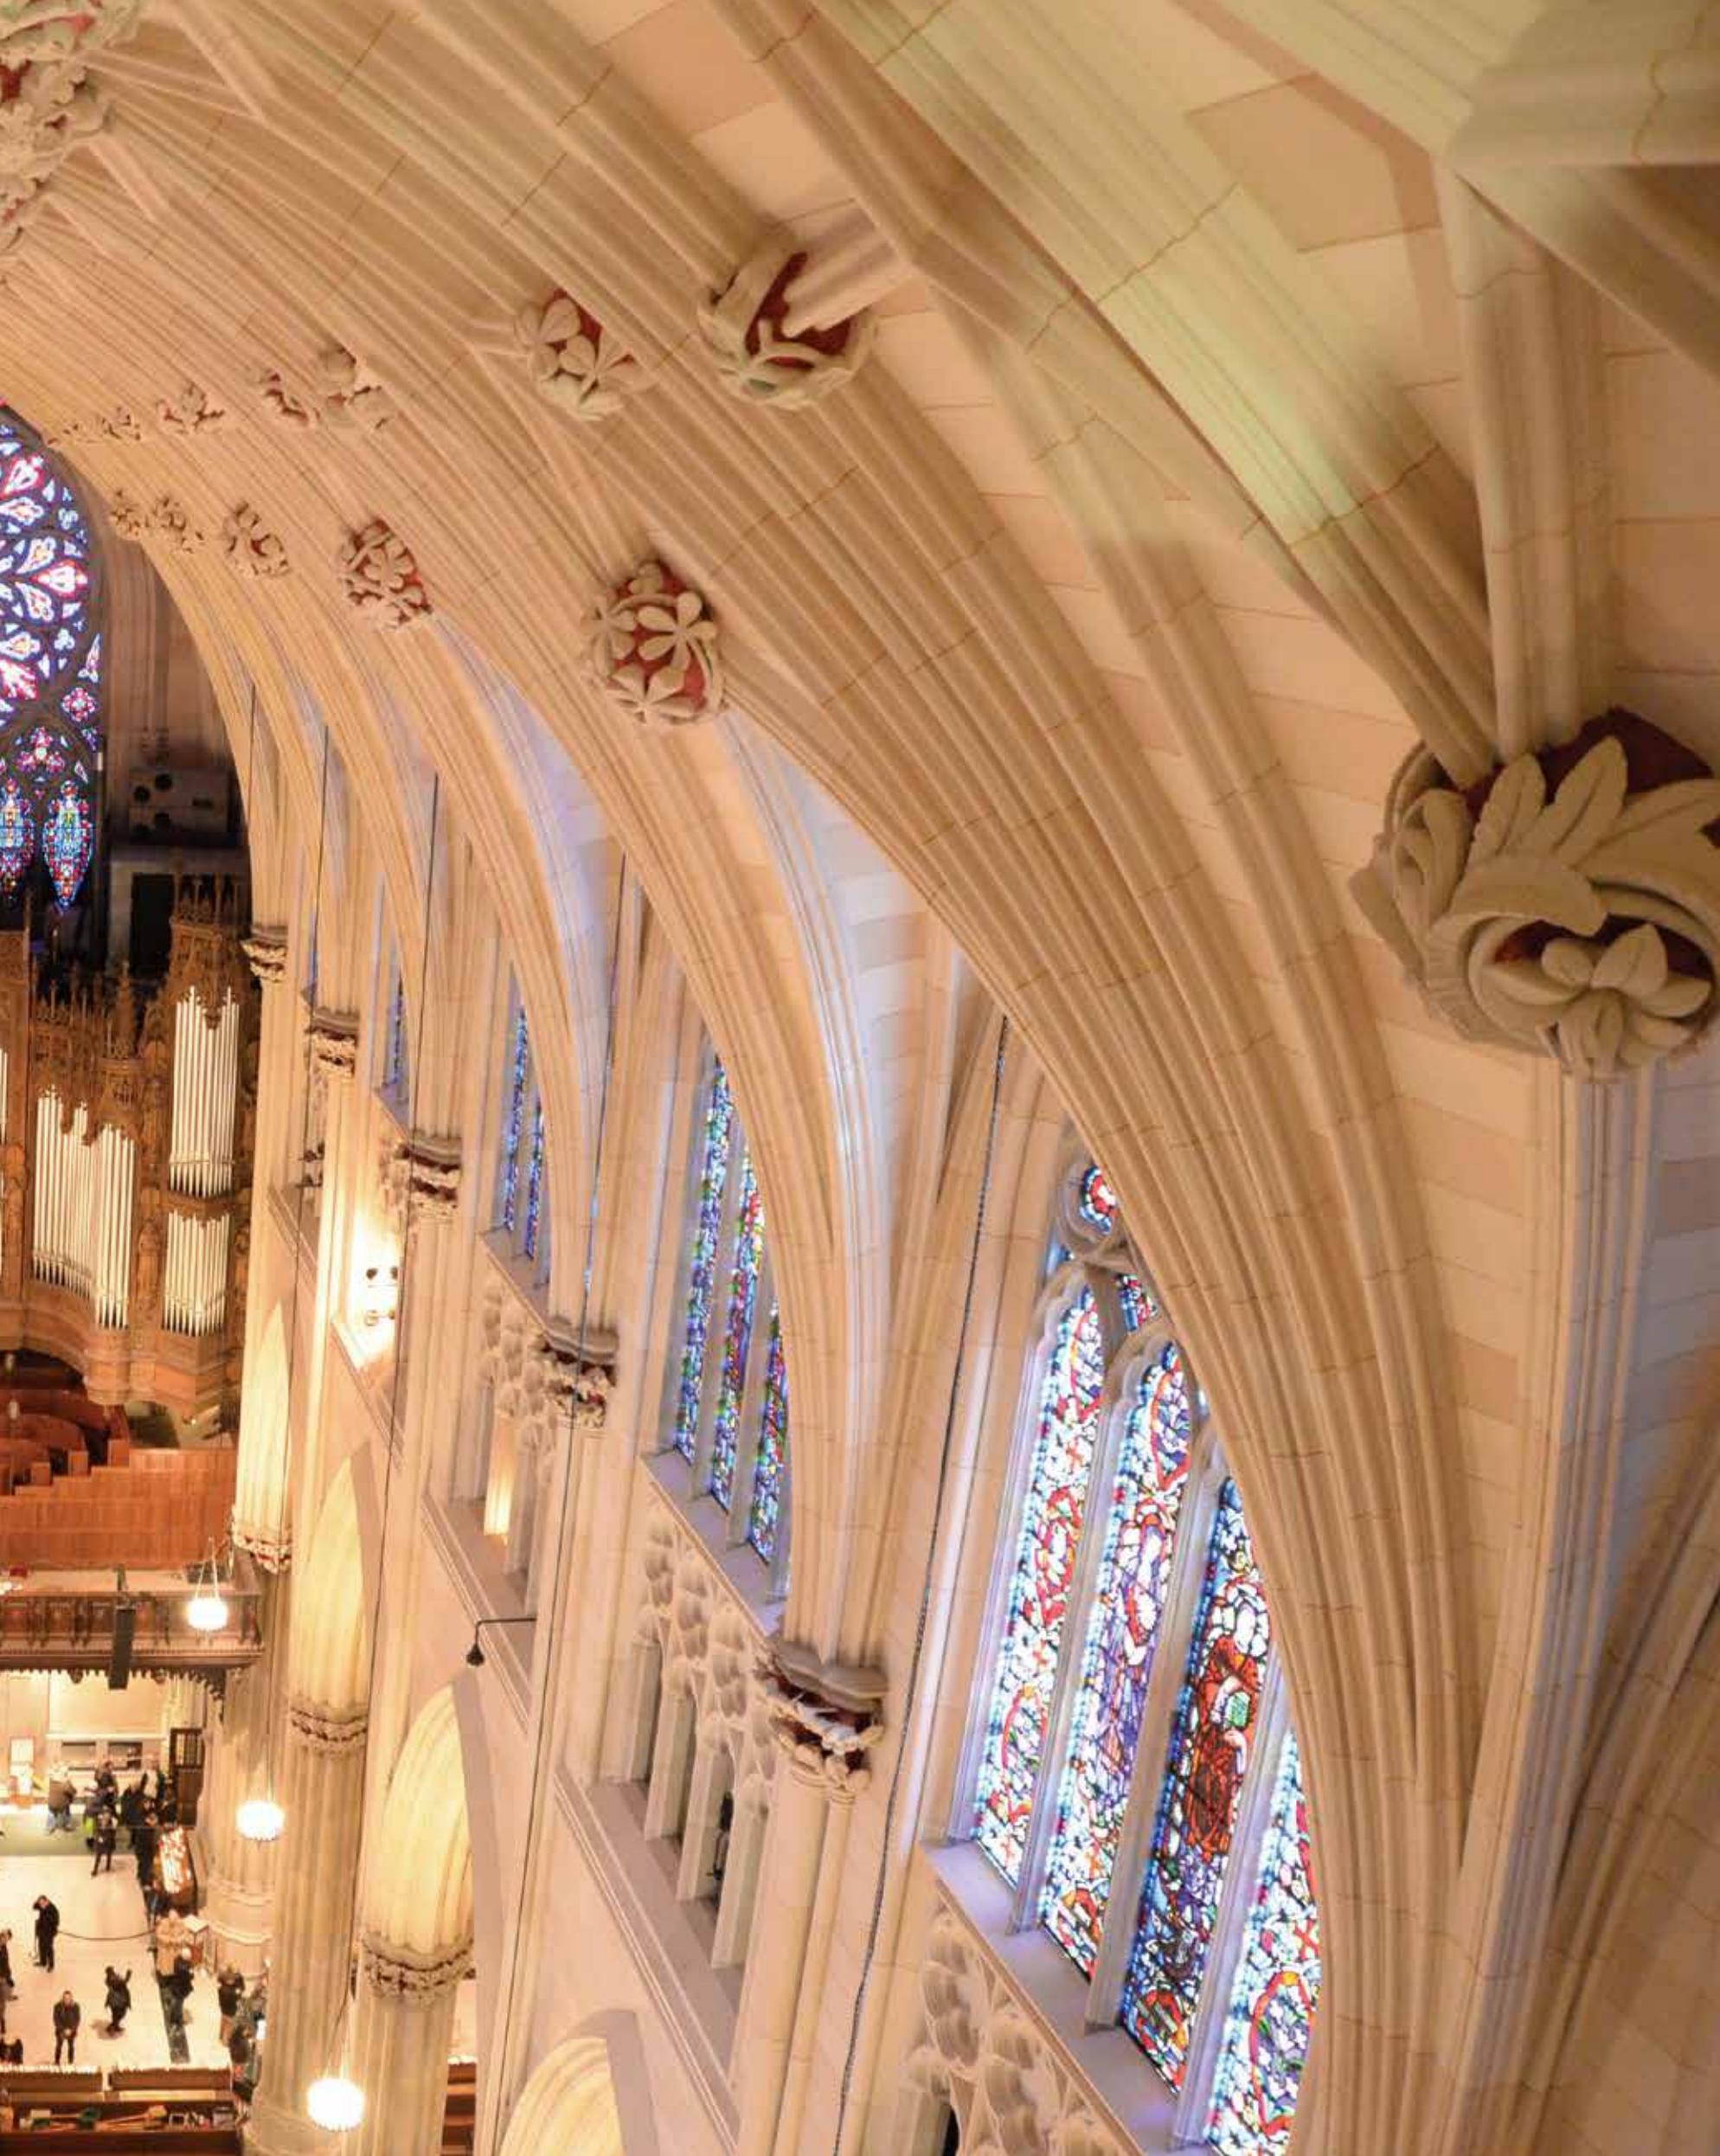
The interior of the 40,000-sq.-ft. cathedral, looking toward the altar, is now much lighter, having been cleaned, restored and repainted. In addition, the restored stained-glass windows now allow more light into the building. Photo: Whitney Cox

The wood lath was cleaned from above and the plaster re-attached and repaired before it was painted three colors to give it the appearance of stone. Before this work started, a large section was cleaned and painted, to show the congregation and owners how much better it would look.

While the new painted interior contributed to the lightness of the interior, the repair and cleaning of the 75 stained-glass windows also brought more daylight into the cathedral. Murphy explains that the stained glass was in better condition than the design team originally thought. “Of the 3,200 panels, we took out approximately 6% to be repaired,” he says. This work was done by Botti Architectural Arts in its studio in LaPorte, IN. They repaired and cleaned the others onsite.

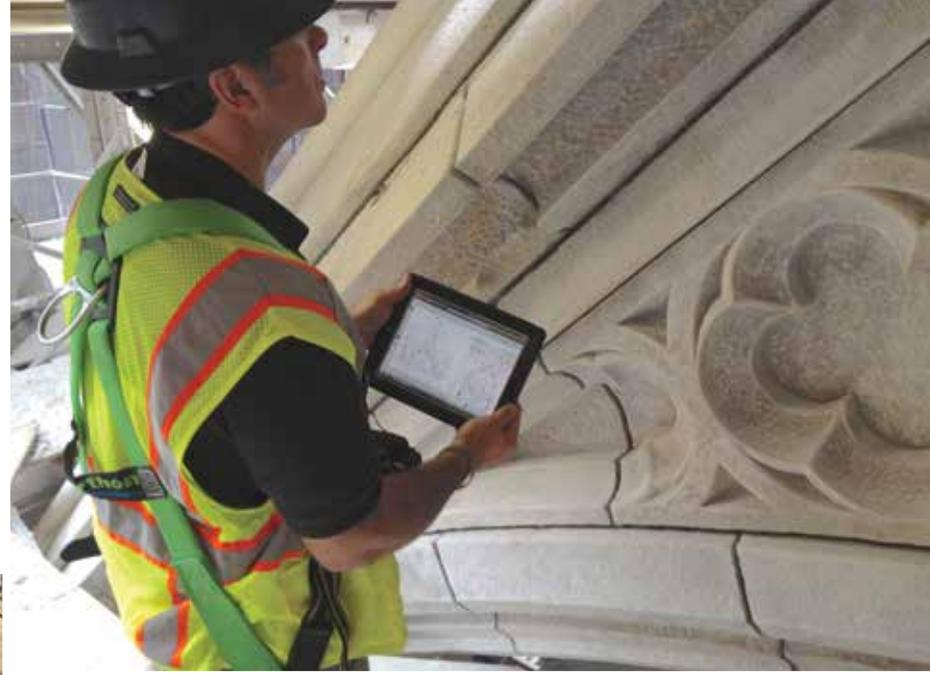
LEFT: Workers in the field were able to record repairs as they were made using ipads and BIM360, and the entire crew could follow the progress instantaneously on their computers and ipads. Photo: Raymond Pepi, Building Conservation Associates, Inc.

A major factor in completing the work in a relatively short time frame – three years – was the use of a software program called BIM360 that stored the entire project in the cloud, allowing all members of the team instant access to it, using ipads in the field and desktop computers in the offices.

“Originally this was scheduled as a five-year project, but the owner requested that we reduce the time frame,” Murphy says. “Having this tool was incredible and helped us shorten the schedule. The alternative, when new work such as a masonry crack was identified, would have been to go back to the office, make a sketch and email it to everyone, and

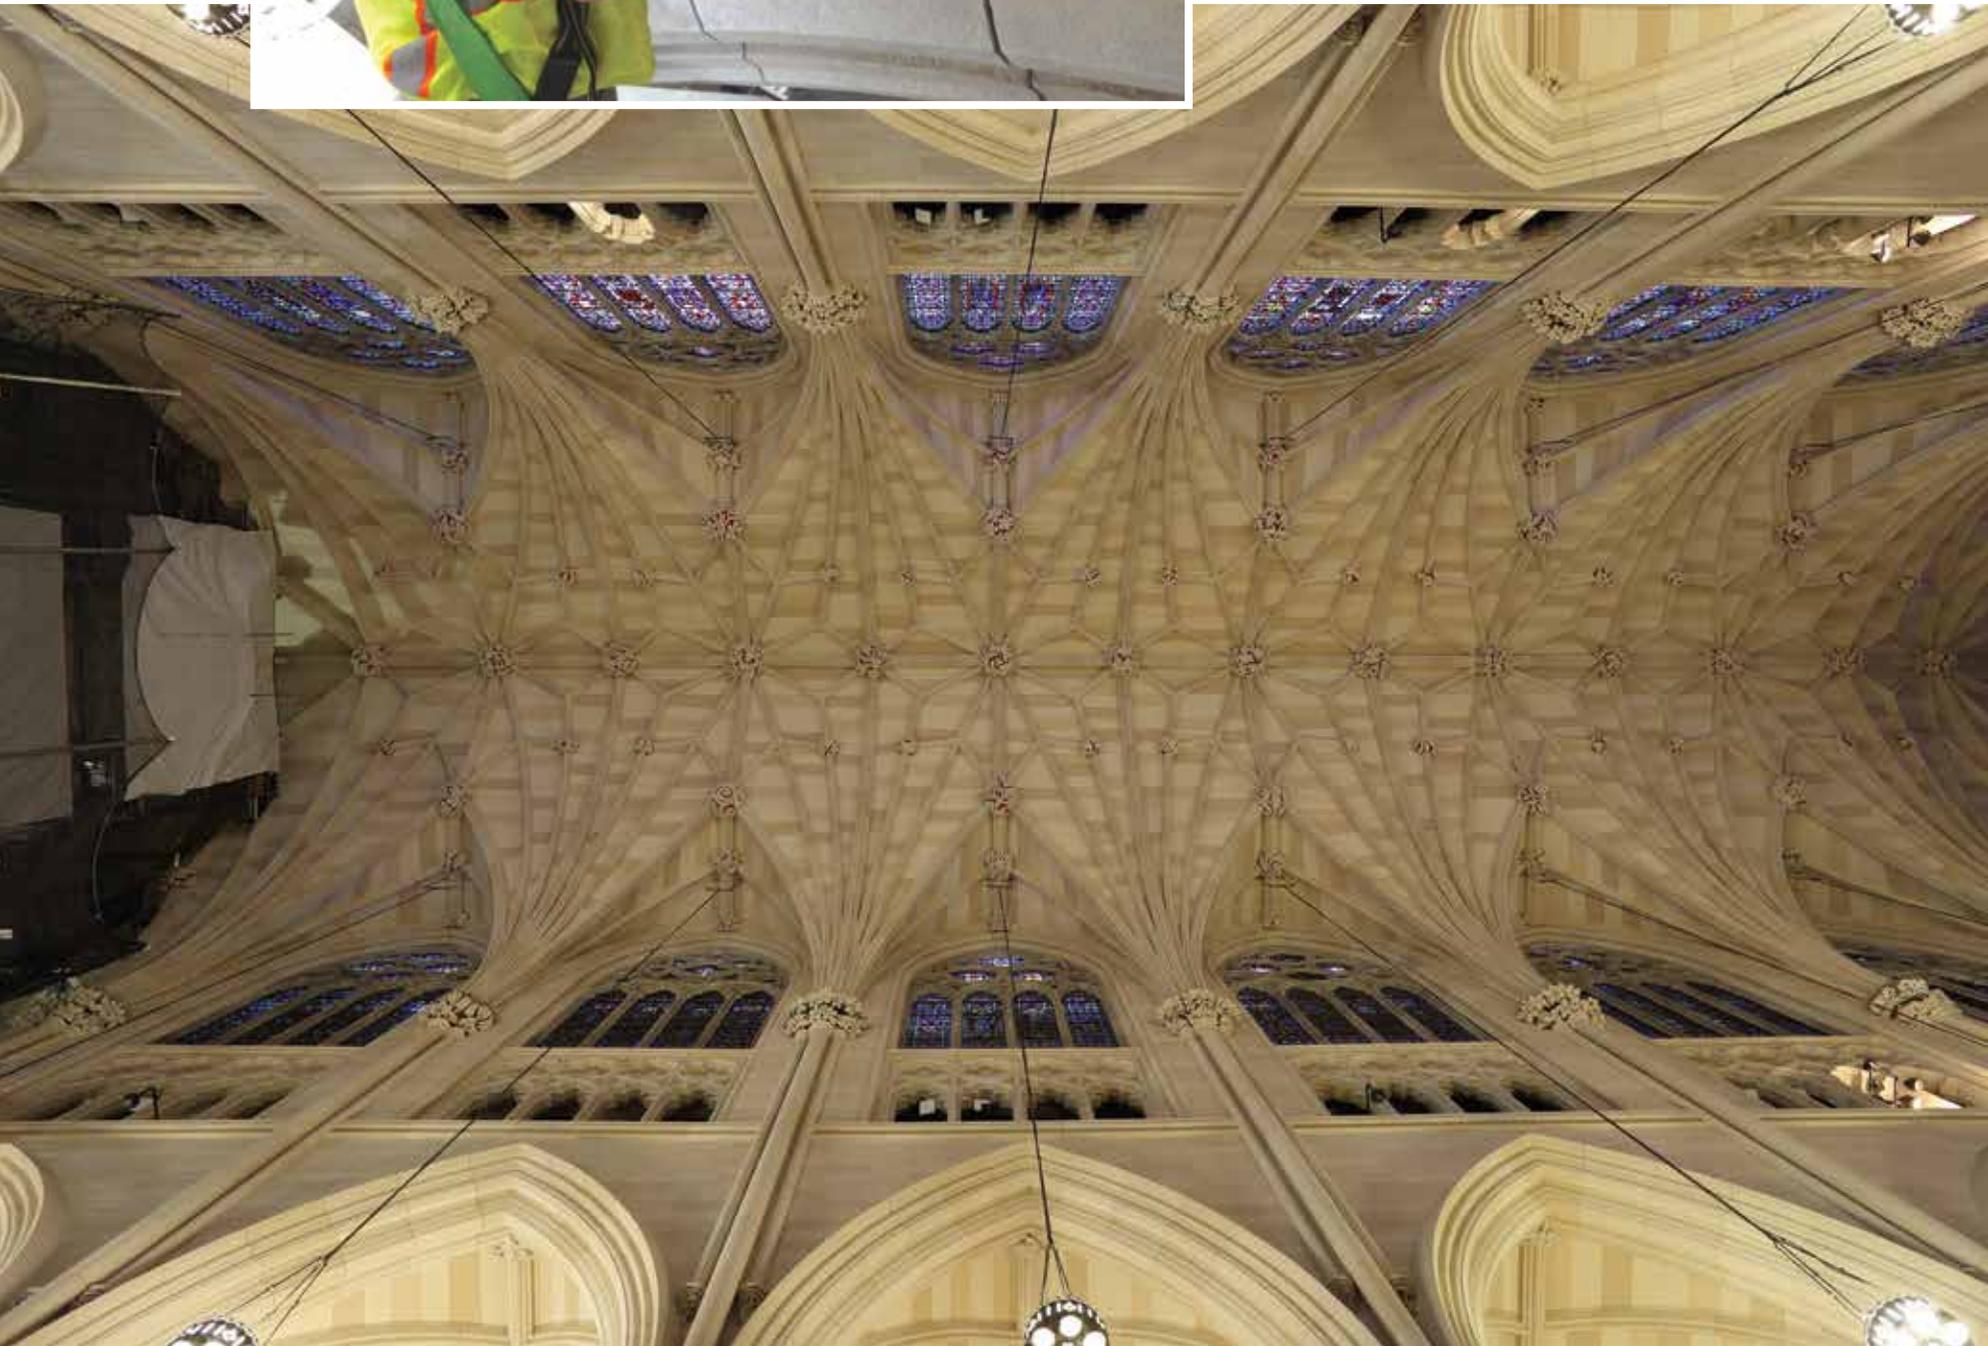
BELOW: The ornate ceiling, like the rest of the interior, has been cleaned and repainted in three colors to give the appearance of stone. Photo: Whitney Cox
